# CITY OF LAS CRUCES

**SUBJECT:** Case 26RB2004618 and 26OC1504639

**Case 26RB2004618 and 26OC1504639:** A request for a Certificate of Appropriateness for the rehabilitation of a property at 425 E. Mountain Avenue. The subject property is zoned R-3; property owner is seeking approval for the replacement of all windows, outright removal of two windows, rear addition to the property including three new windows, and the installation of metal standing seam on the roof. The replacement windows and rear addition were constructed outside the City's permitting process; the roof was approved without consultation by the Historic Preservation Program; all are presented for retroactive approval to the Historic Preservation Committee (HPC) by way of acquiring a permit. The building was constructed between 1940 and 1950 and captured within the State Register Historic District listing for the Mesquite Street-Original Townsite but is not contributing to the State Register Historic District listing; it is within the South Mesquite Overlay (SMO). An application for a retroactive permit for construction has been submitted by the property owner, Carlos Almaraz, with retroactive drawings developed b

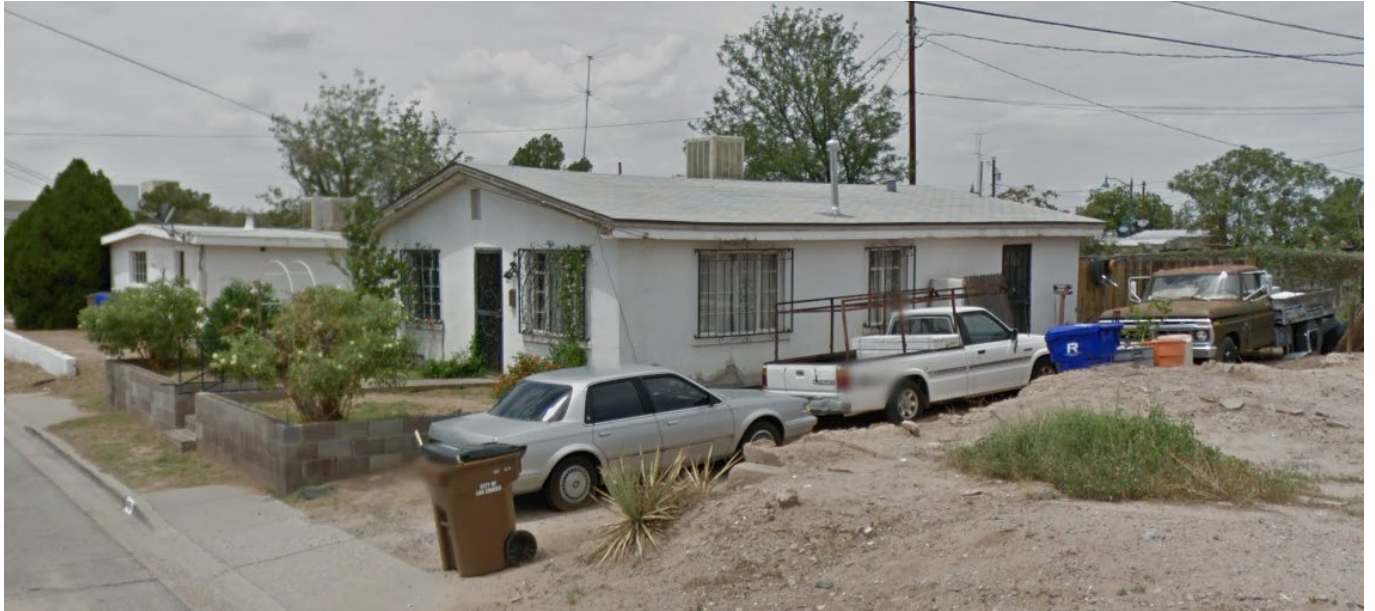
*Figure 2: Google Streetview screenshot of house, circa 2011, showing original metal casement windows and doors.*

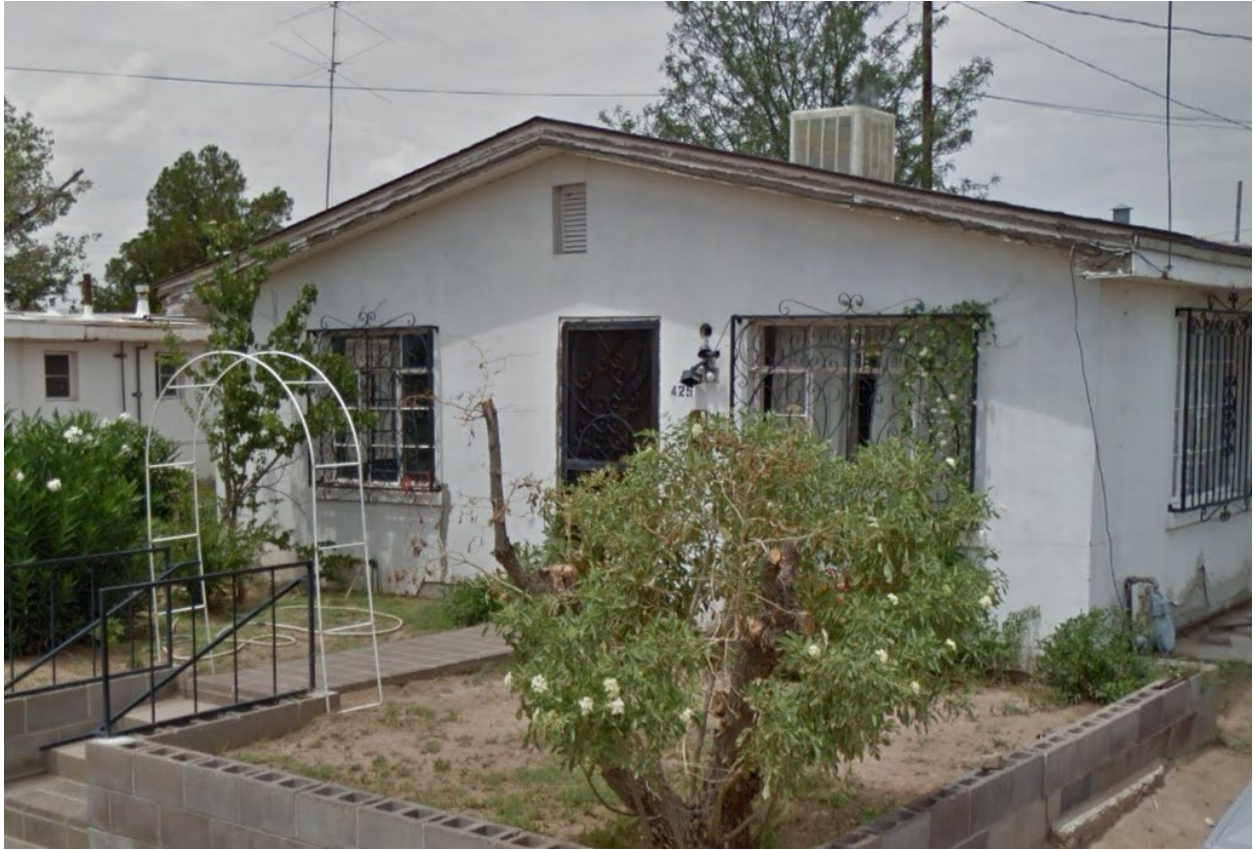
*Figure 3: Google Streetview screenshot of house, 2011, showing front windows.*

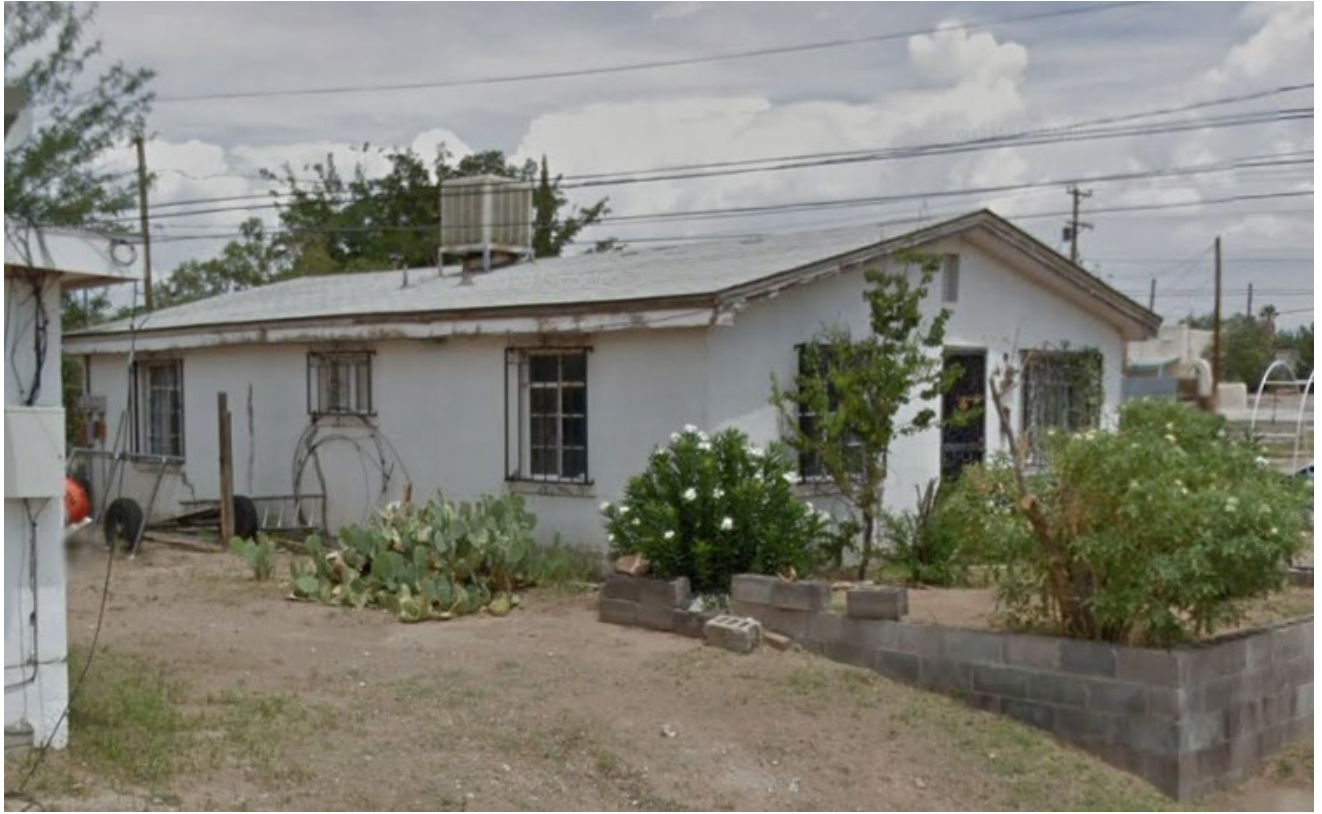
*Figure 4: Google Streetview screenshot of house. 2011, showing windows on the west façade.*

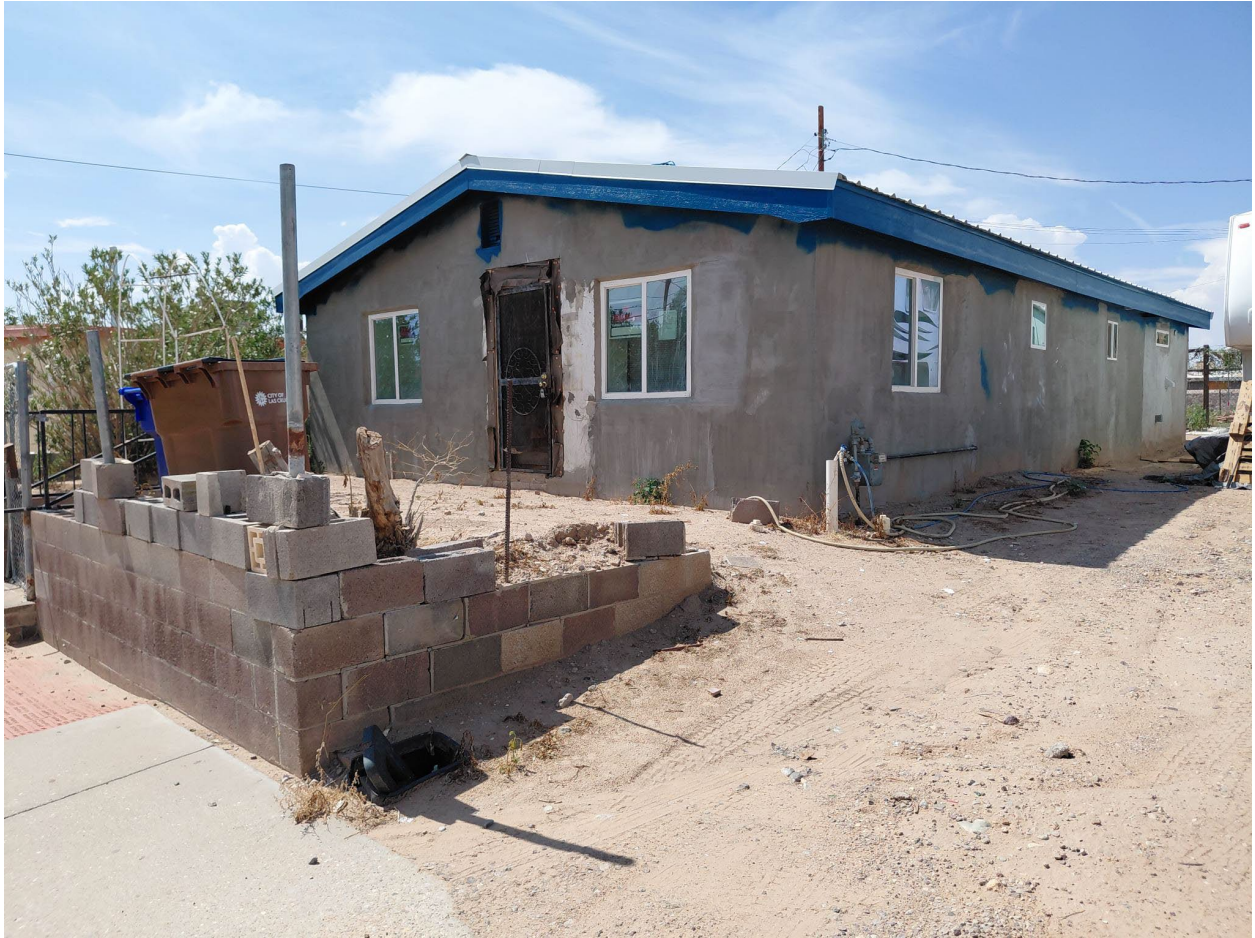
*Figure 5: Property at 425 from Sidewalk along Mountain Avenue, showing new windows and addition to the rear.*

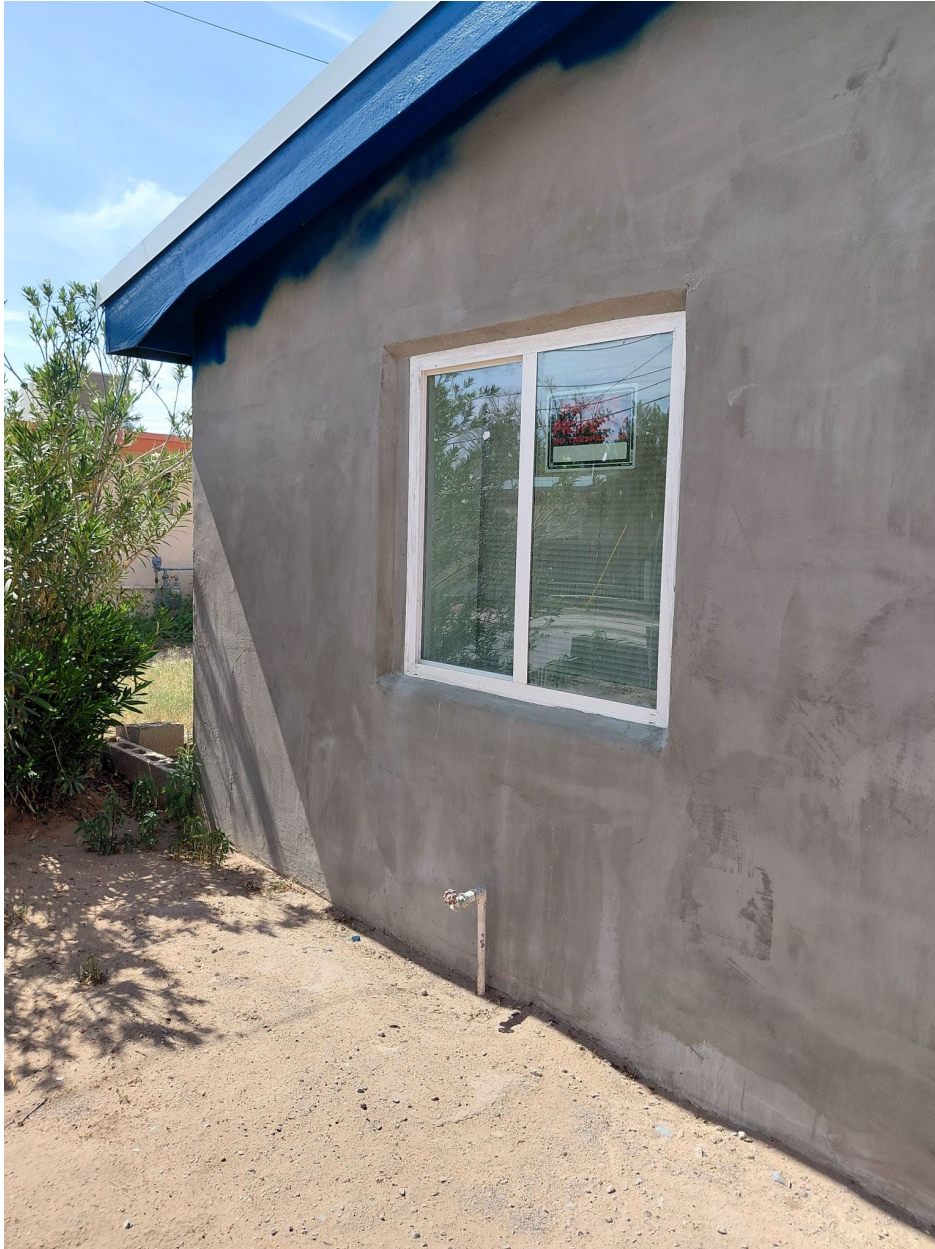
*Figure 7: Replacement window on front façade, to the left of the front door.*

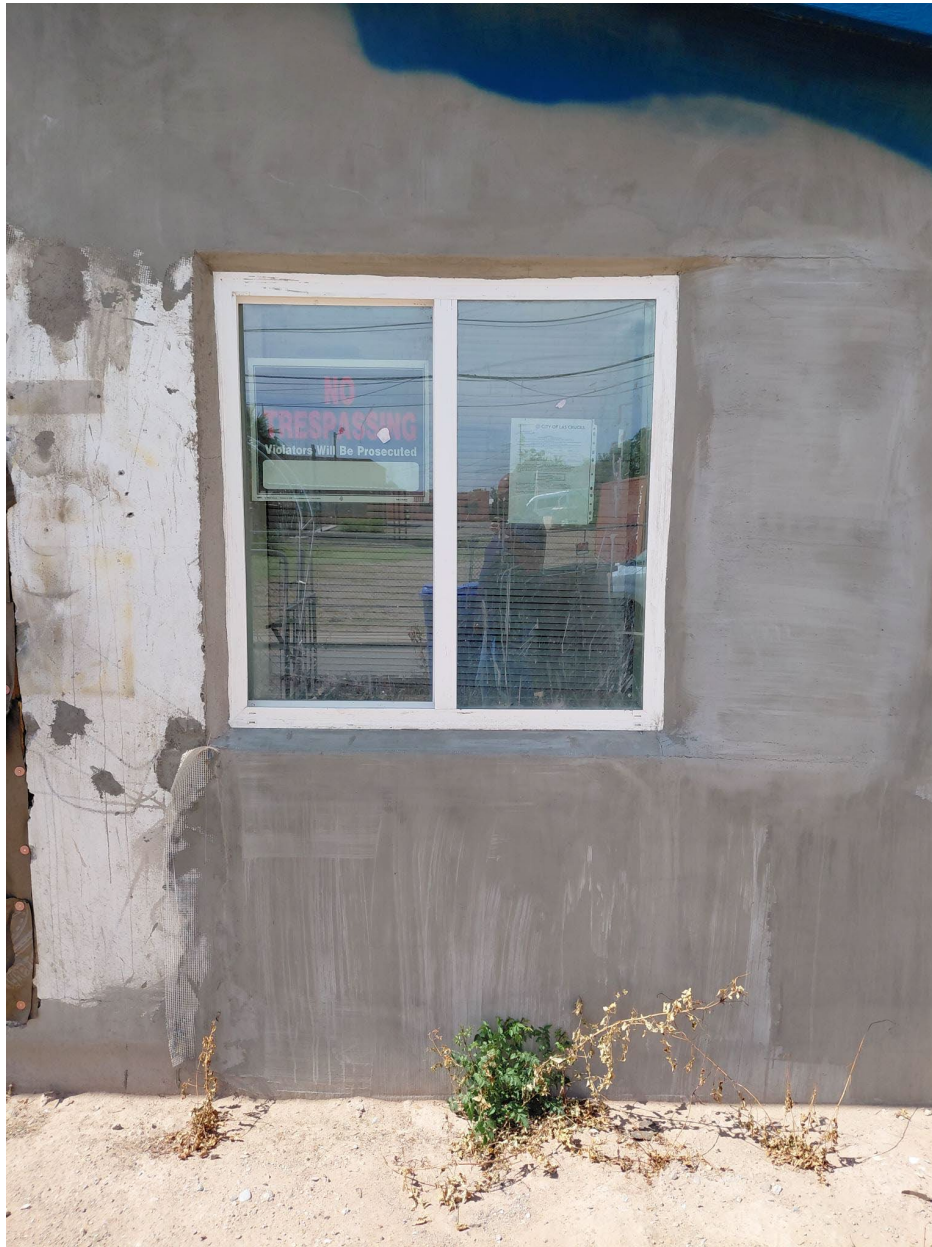
*Figure 8: Replacement window on front façade, to the right of the front door.*

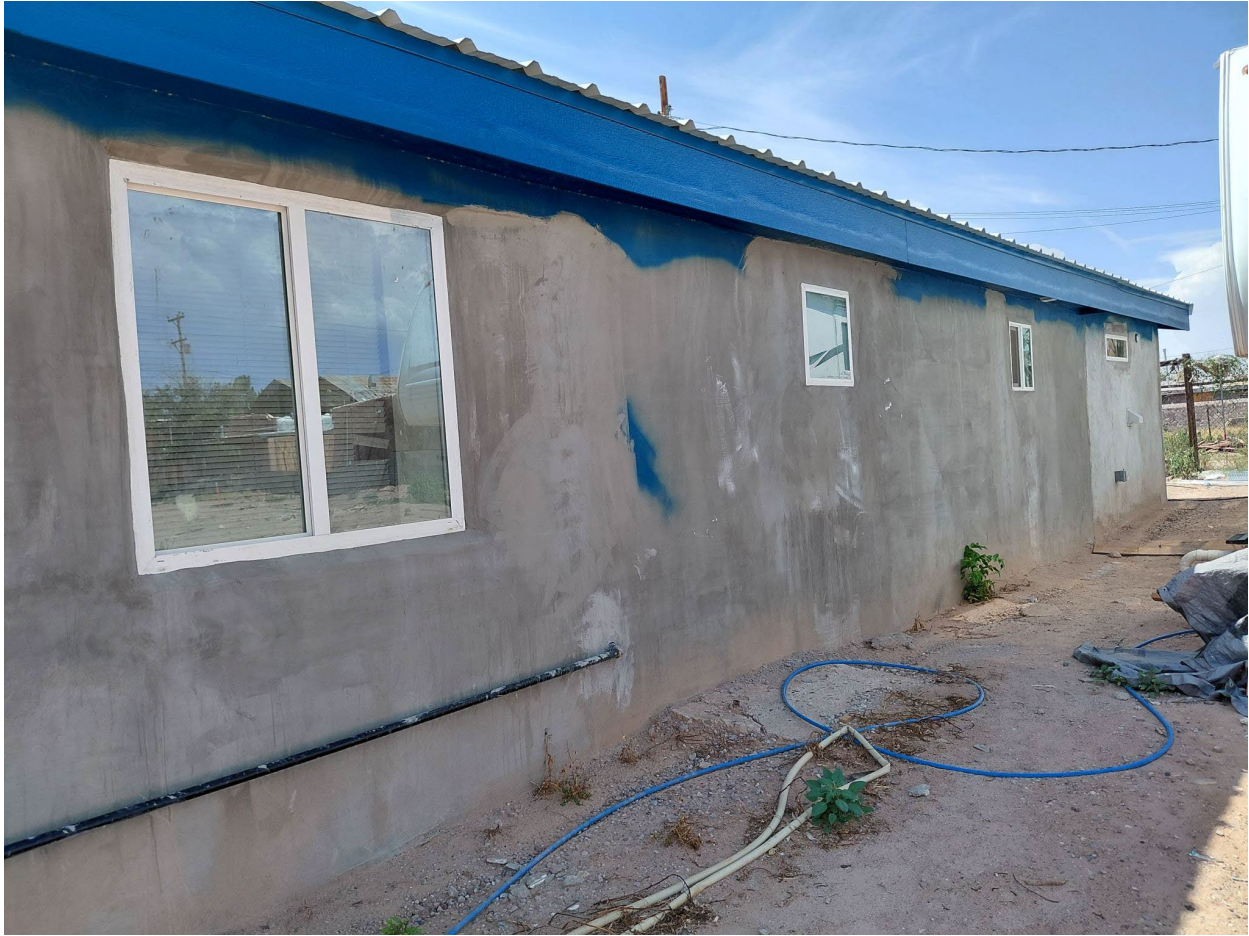
*Figure 9: East façade of property, showing new windows, including removal of side doorway and addition to the rear.*

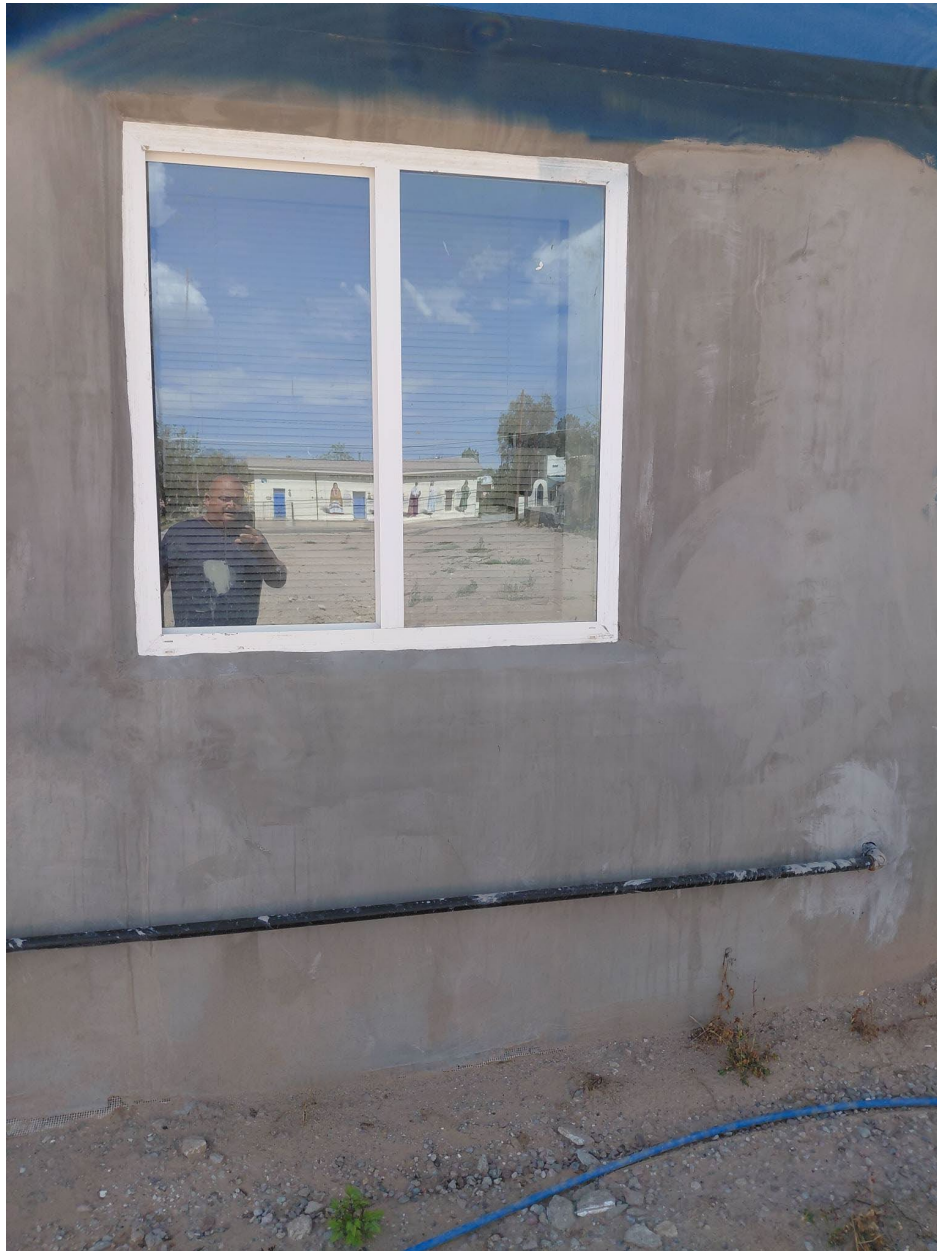
*Figure 10: Window closest to front of building on east façade, formerly a steel casement window.*

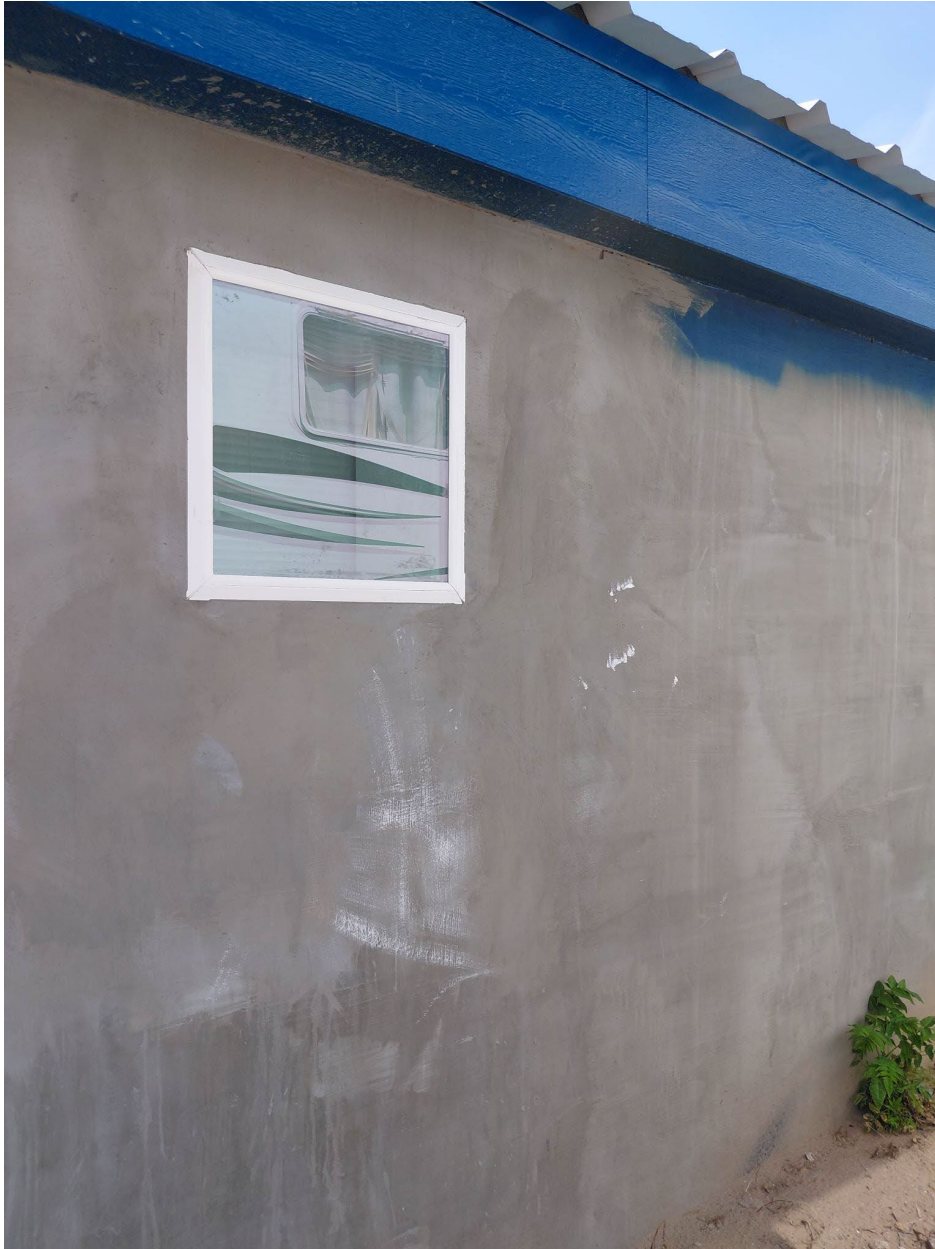
*Figure 11: Former location of steel casement window with transom, now a fixed inoperable window.*

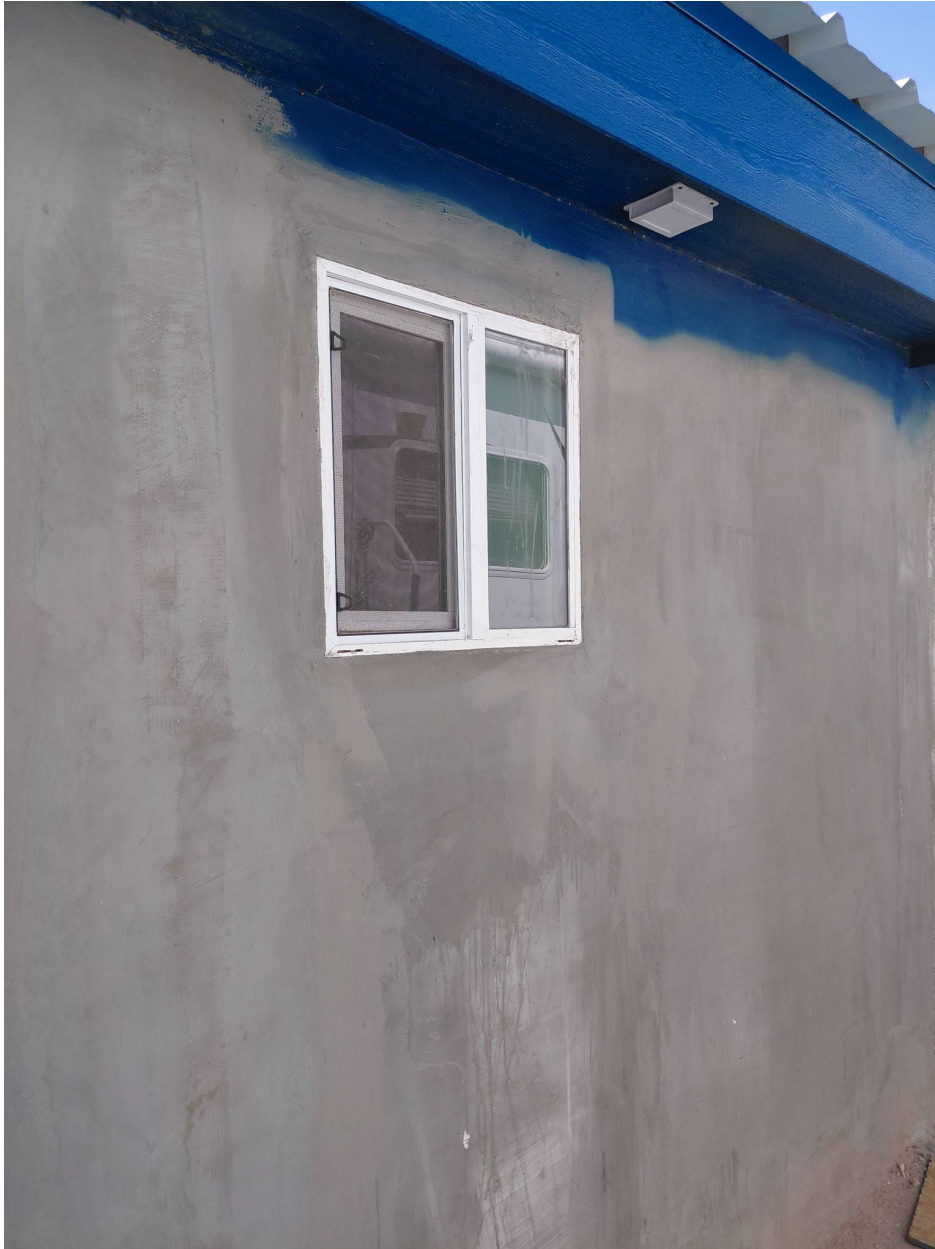
*Figure 12: Former location of side door, now small slider.*

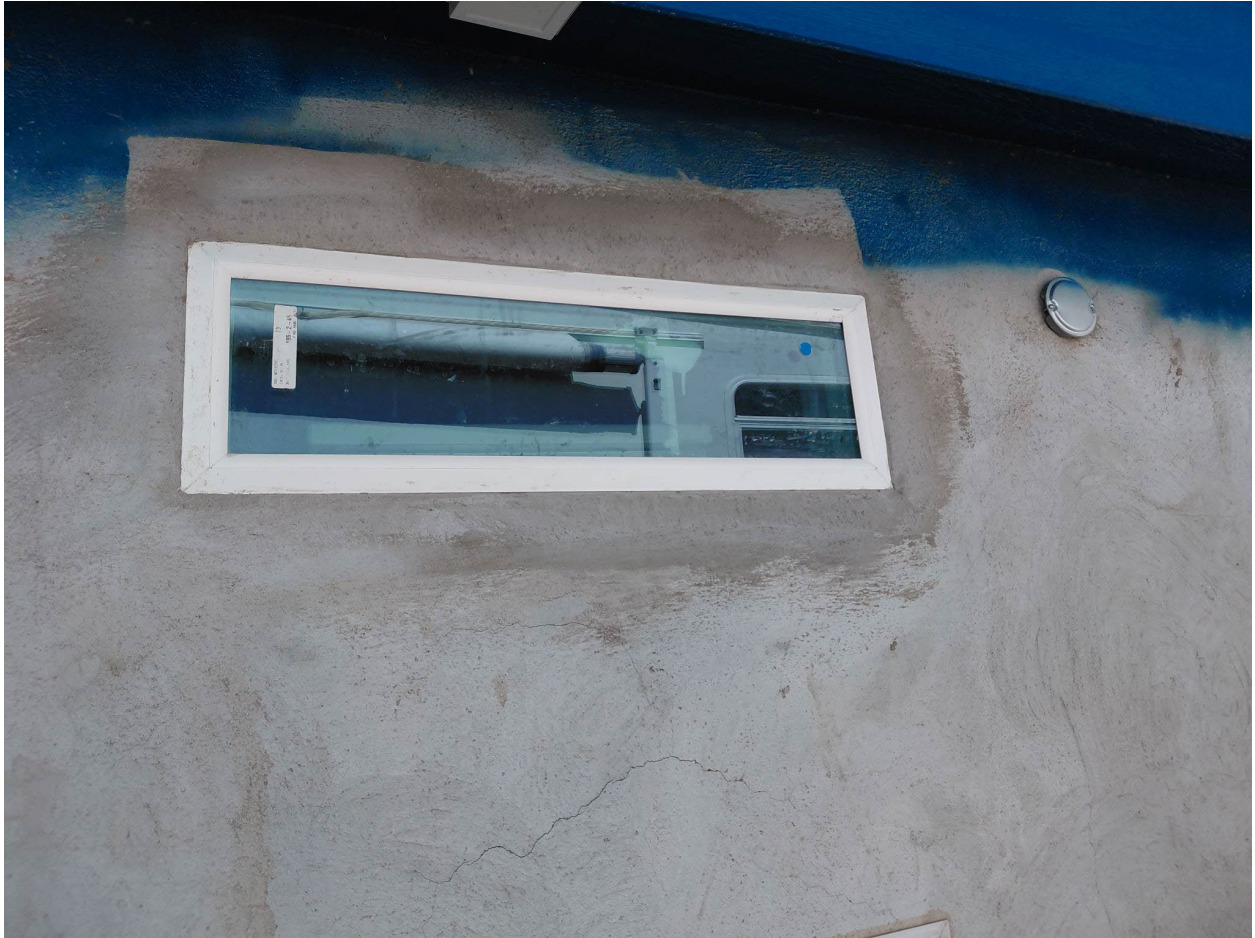
*Figure 13: Clerestory window on addition.*

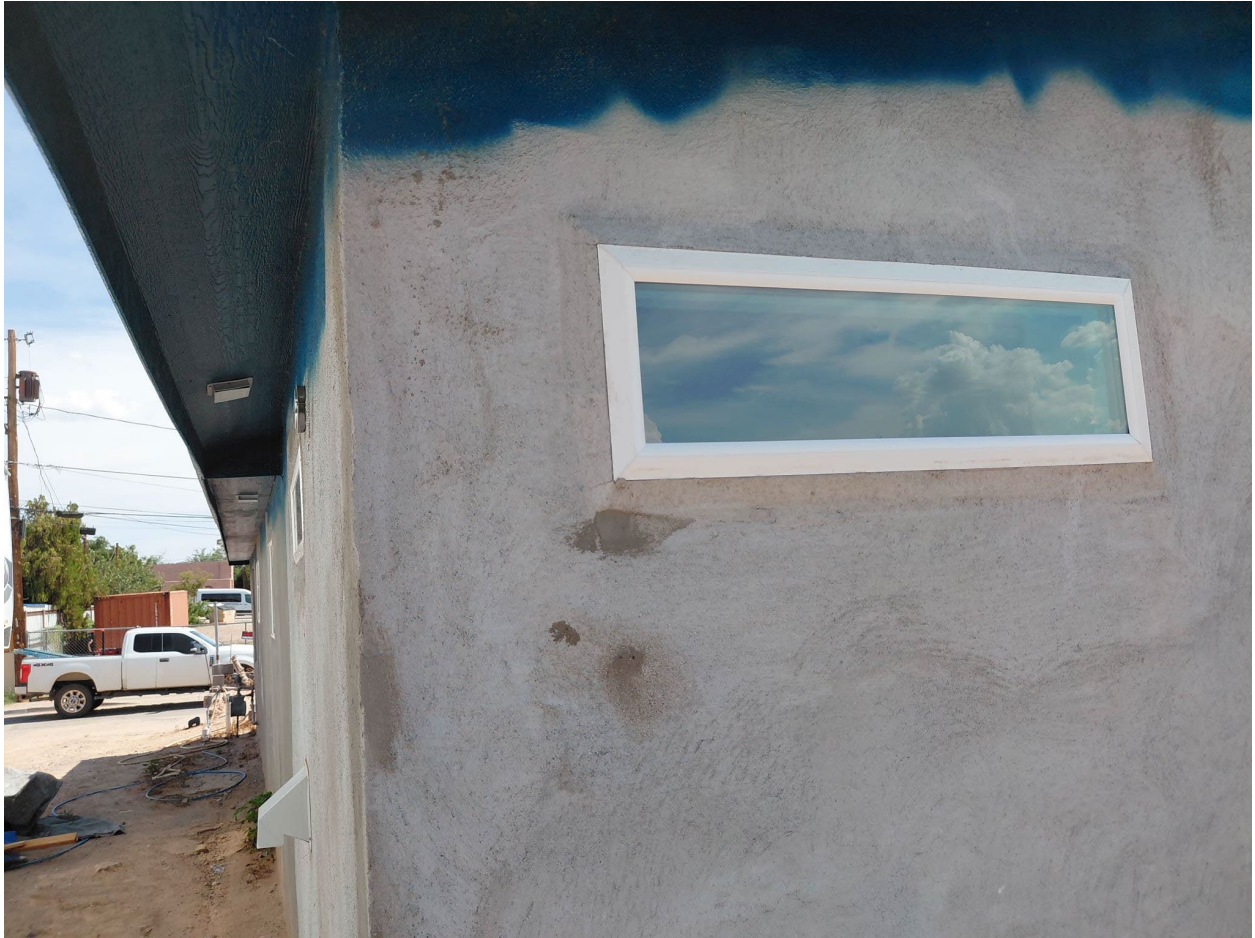
*Figure 14: Clerestory window on north façade of addition.*

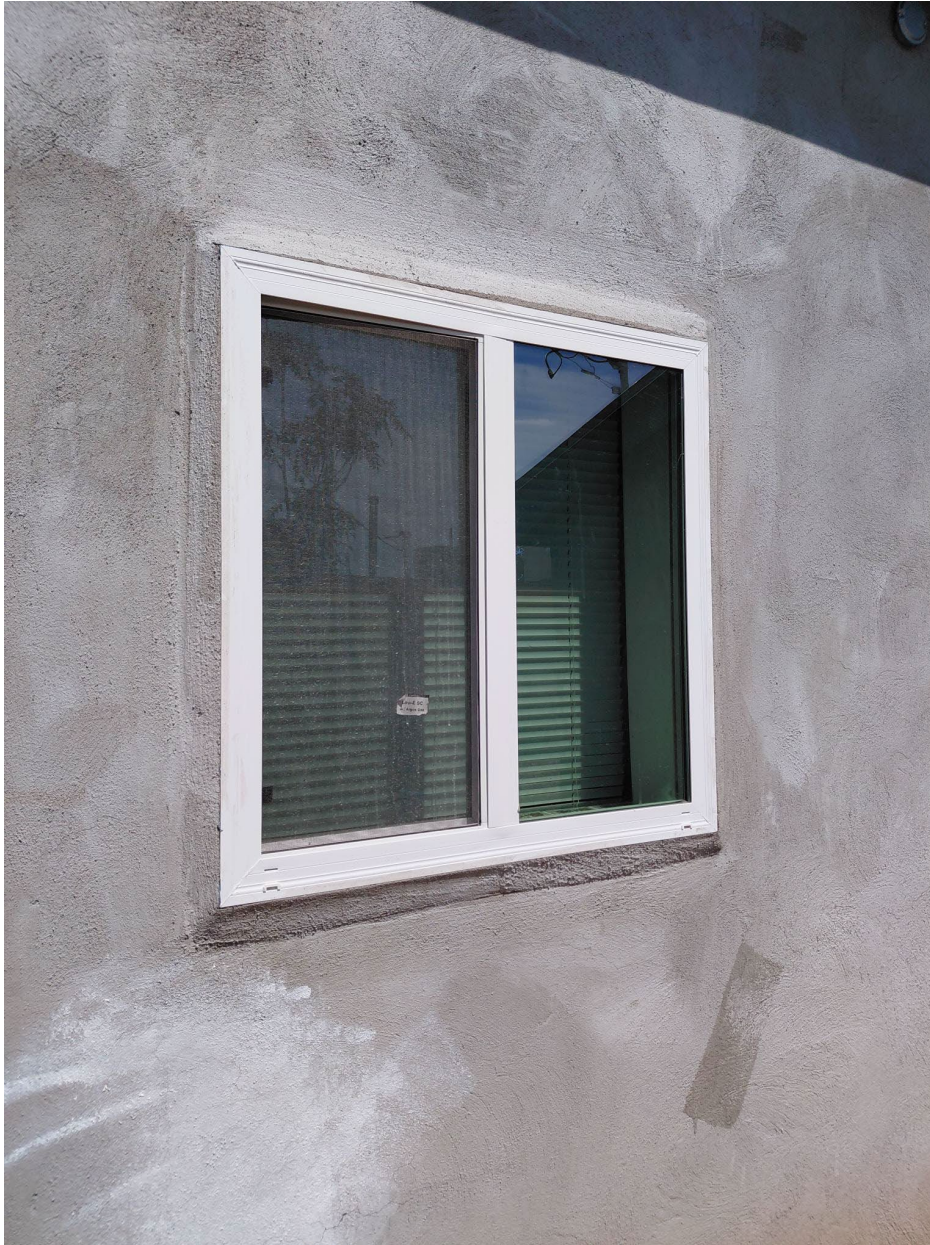
*Figure 15: New slider on west façade of addition.*

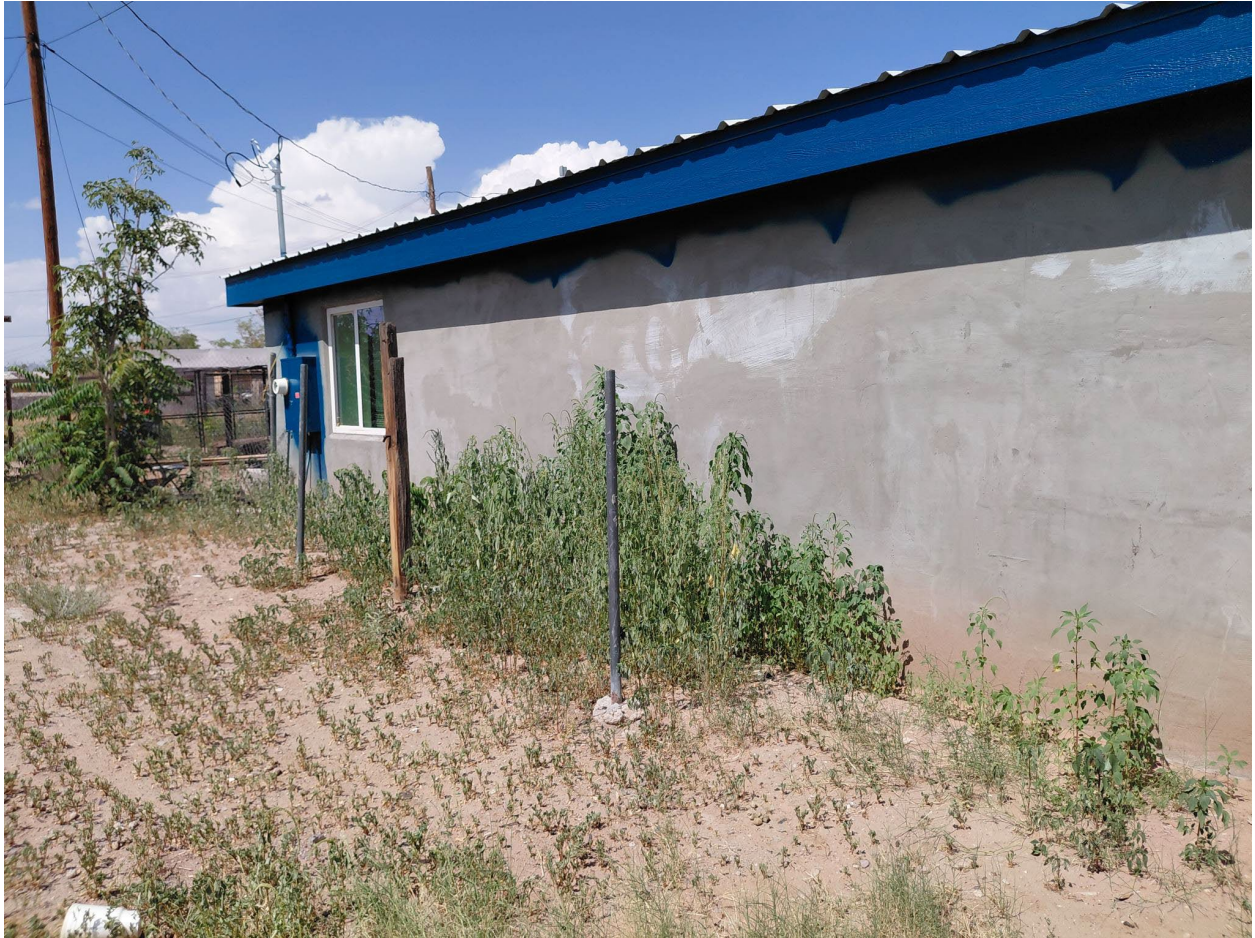
*Figure 16: Slider on north side of west façade; two windows have been removed.*

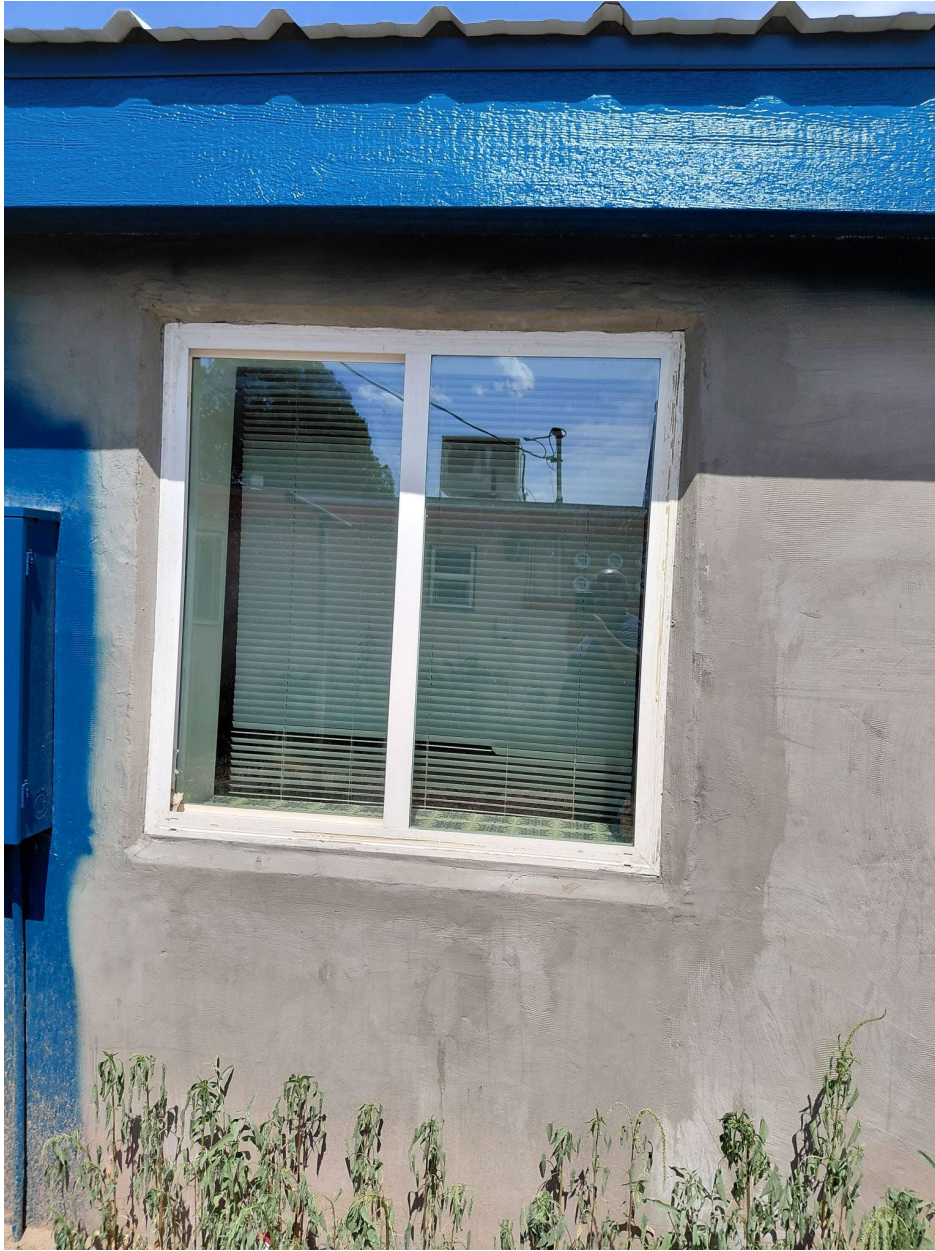
*Figure 17: New window on west façade.*
