Waste Excavation Plan

PRE-1965 FOOTHILLS LANDFILL Las Cruces, New Mexico

June 2019

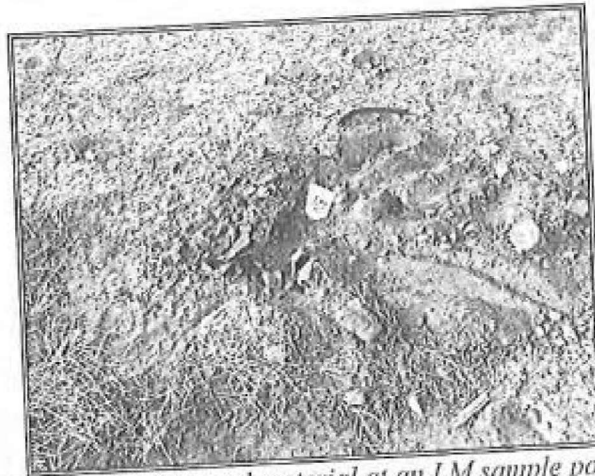
Oxidized and burned material at an LM sample point

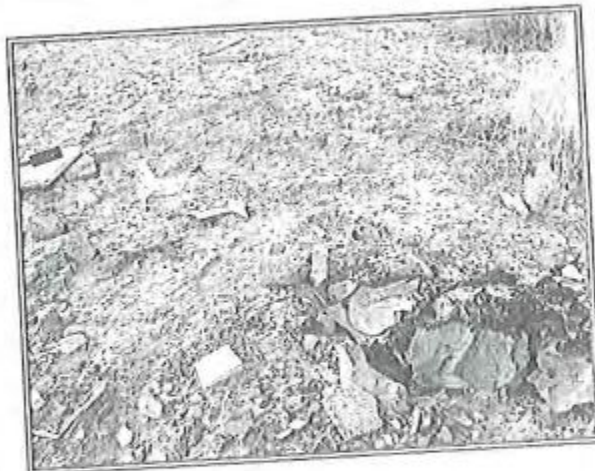
View of suspect ACM

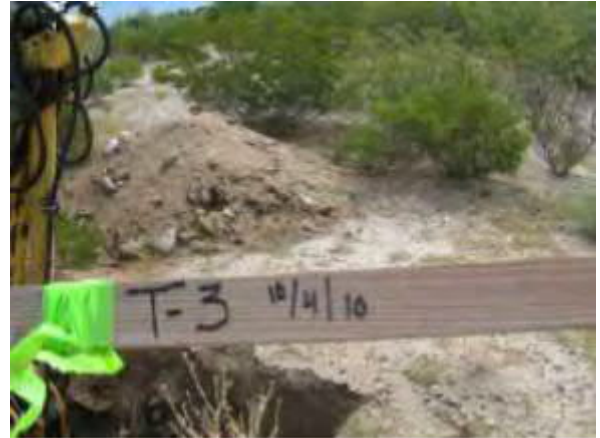
Photo #2 Test pit 3, debris.

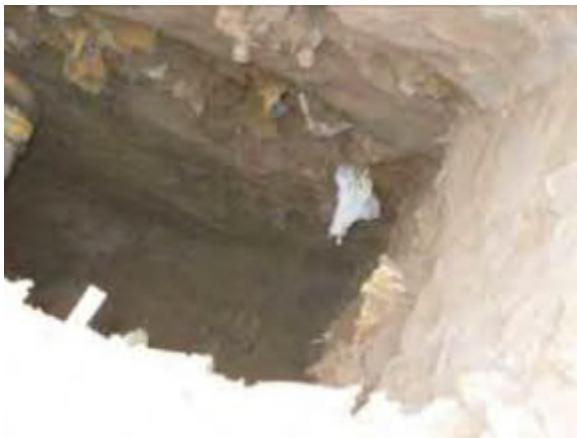
Photo #3 Test pit 4, debris.

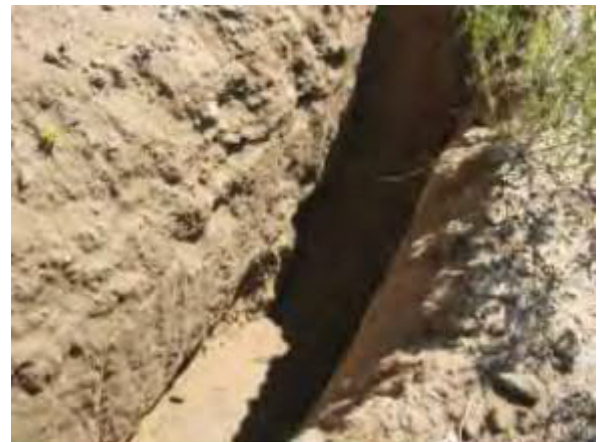
Photo #4 Test pit 5, clean.

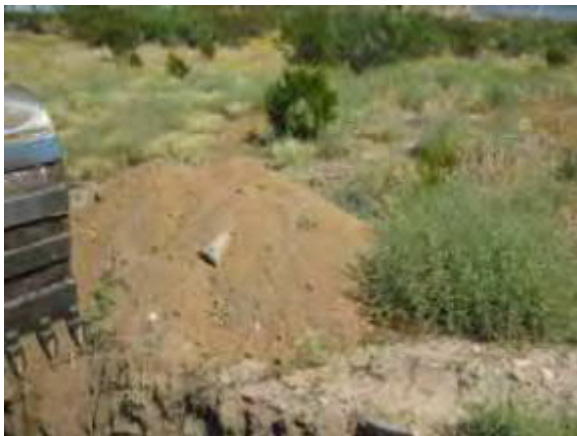
Photo #5 Test pit 6, minor debris.

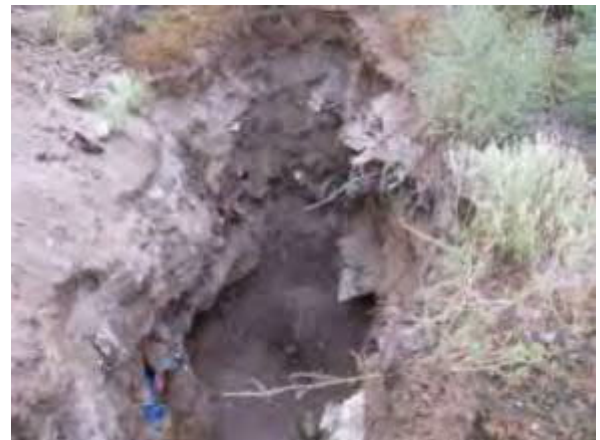
Photo #6 Test pit 12, debris.

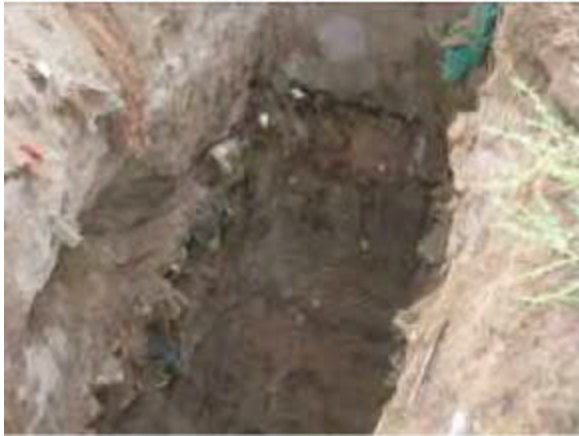
Photo #7 Test pit 13, debris.

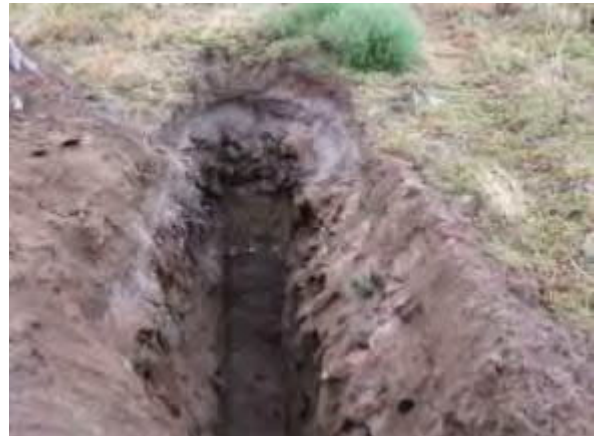
Photo #8 Test pit 14, debris.

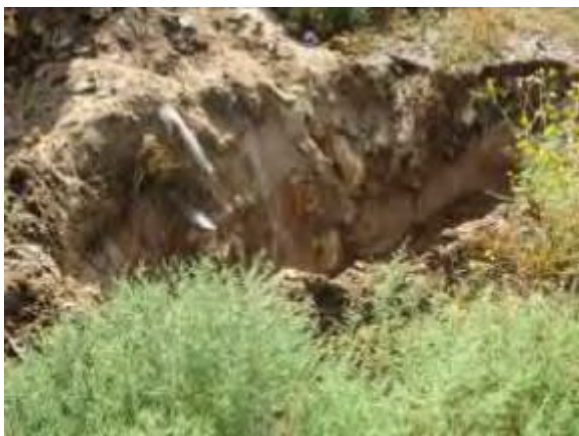
Photo #9 Test pit 15, debris.

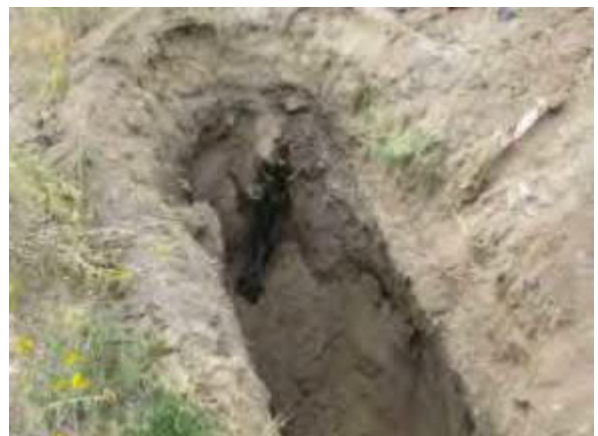
Photo #10 Test pit 2, minor debris.

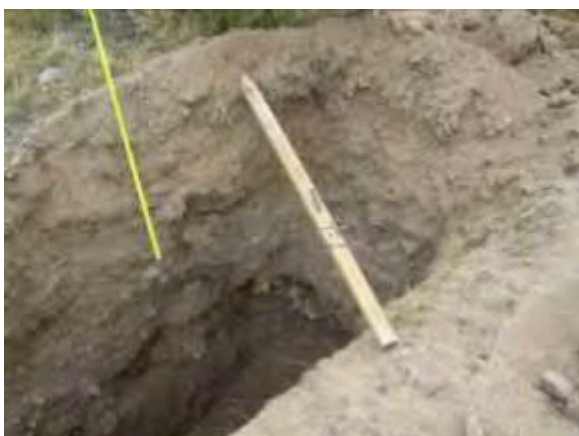
Photo #11 Test pit 1, minor debris.
