Appendix A. Mesquite Street-original Townsite Historic District Reconnaissance Survey Final Report

Mesquite Neighborhood Design Plan

May 2007

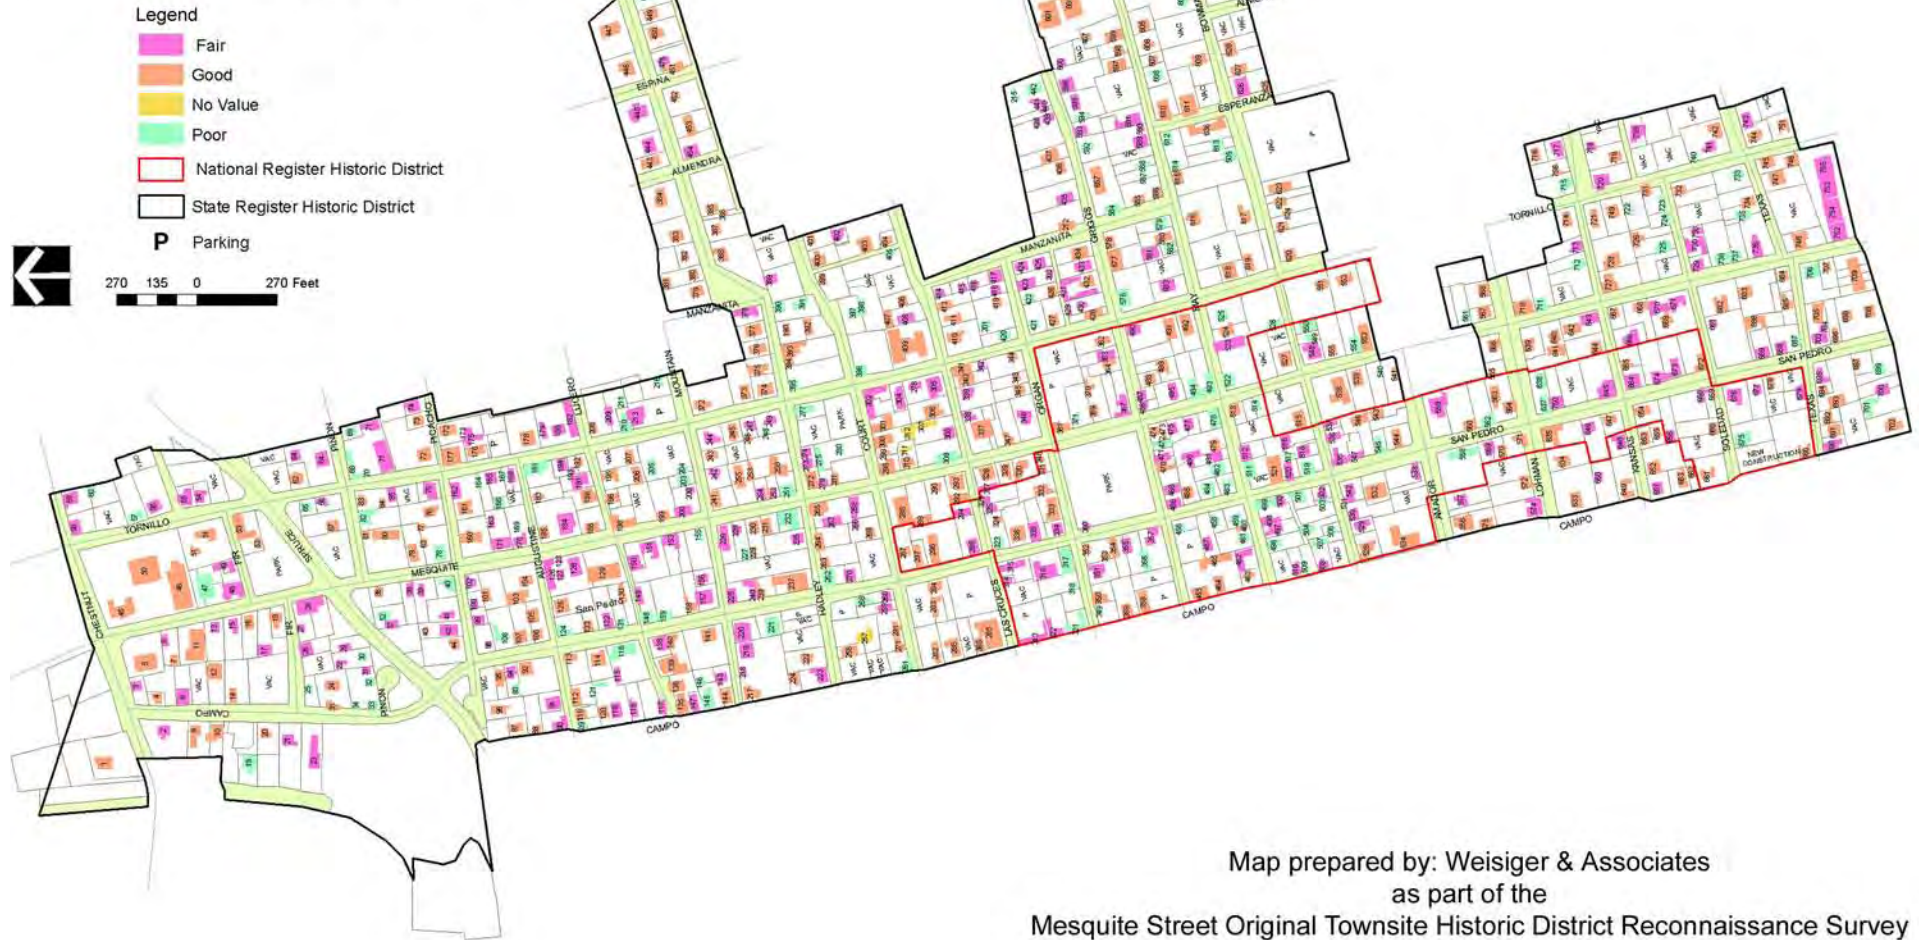
Map 3. Building Condition

Building Condition - August 2004

- **Building Condition:** Of the 700 buildings, 343 (49 percent) were in good condition, 212 (30 percent) were in fair condition, and 139 (20 percent) were in poor condition.

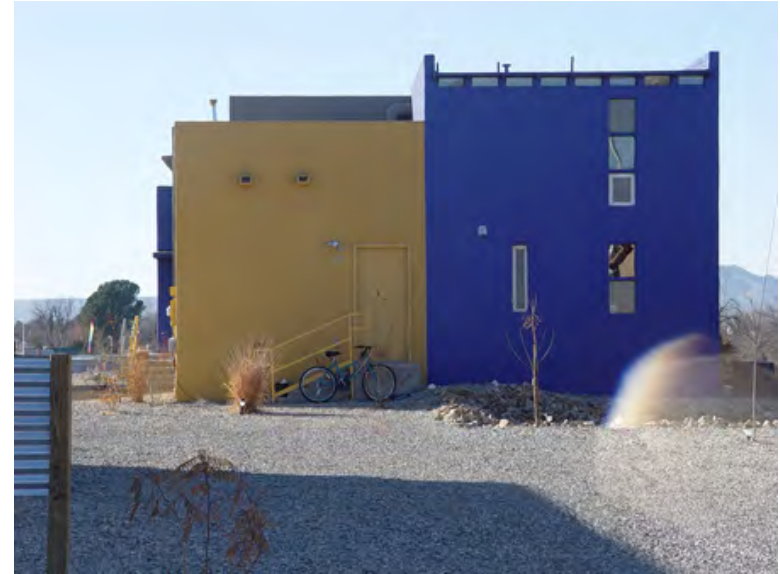
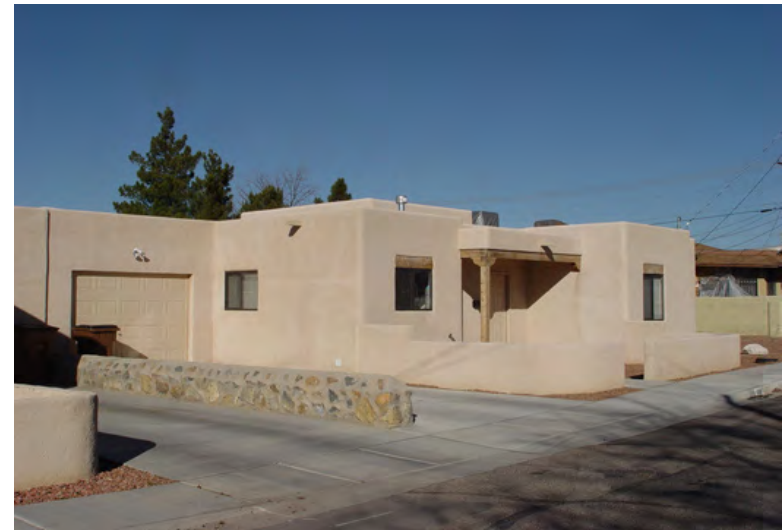
There are a number of vacant lots in residential areas located within both the National and State Register historic districts. These lots are the ideal starting point for the development of residential infill projects to create, restore, rehabilitate, and maintain affordable housing in the Mesquite Neighborhood that also further enhances the character of the existing neighborhood. A Design Overlay Zone has recently been adopted that regulates setbacks and presents design guidelines for new construction. A secondary intent of infill development is to increase home ownership and owner occupied housing within the neighborhood. Any new residential development should be built in a style that reflects the existing historically “contributing” buildings. New homes should be designed and constructed with architectural details and materials that “fit in” with the existing historic homes and capture the spirit of the neighborhood while remaining distinctive from the historic fabric. Ideally any new construction should not be an exact replica of any existing building within the district, but simply be made to blend in seamless with the surrounding neighborhood and look as if it had been constructed in or before 1955 by utilizing design, craftsmanship, materials, and colors that would have been in use during that time. Therefore, the use of materials such as adobe and lime stucco and the replication of historic rooflines and window and door placement styles are recommended. Core areas that could be developed with infill sites are illustrated in the Priority Infill Sites Map on the following page (see Map 10).

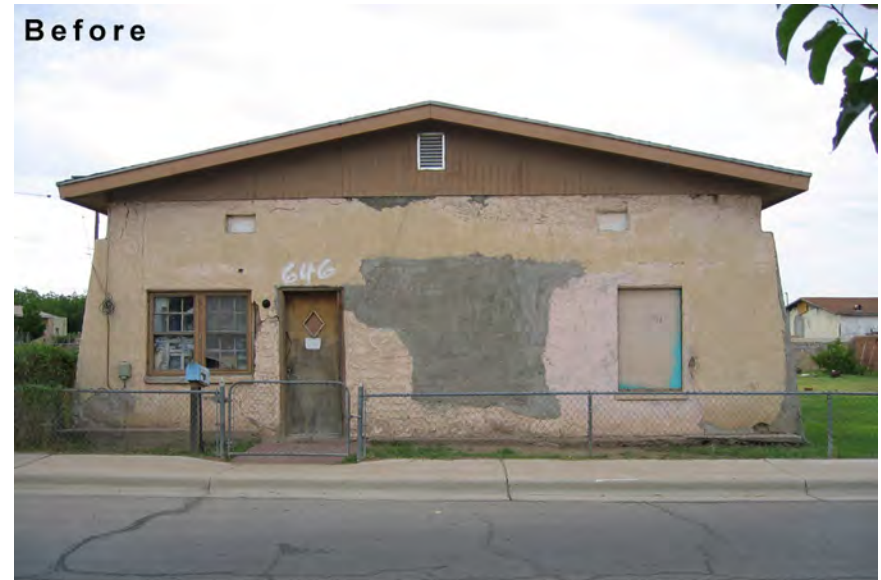
Although buildings throughout the historic district could always benefit from some level of façade enhancement, areas within the historic district that could become core areas of enhancement are illustrated in the Priority Façade Enhancement Sites Map on the following page (see Map 12).

Priority Facade Enhancement Site Areas
(These areas contain a high concentration of "Historically Contributing Buildings" that are in "Fair" Condition as determined by Weisiger & Associates as part of their Mesquite Street Original Townsite Historic District Reconnaissance Survey Study)

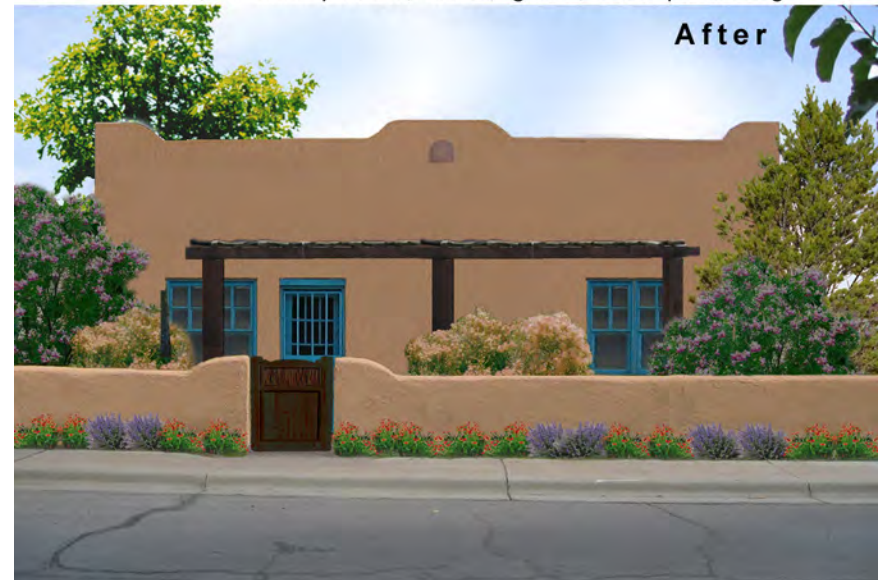
The enhancements shown below include a new, more traditional roofline as well as a new door and windows, new stucco, a new porch, wall, gate, and plantings

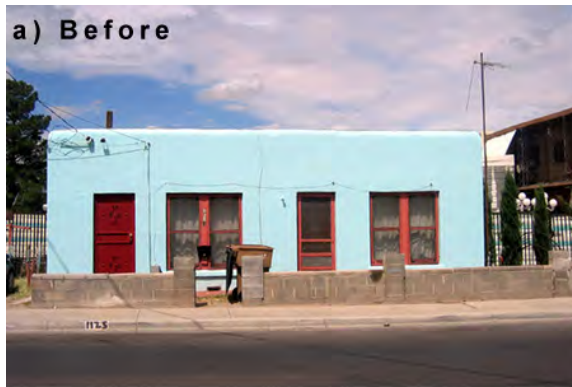
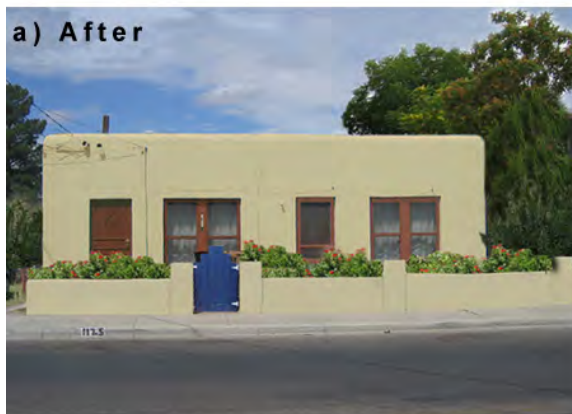
Facade enhancements shown above include new paint on the house & wall, a new gate, and new trees & shrubs

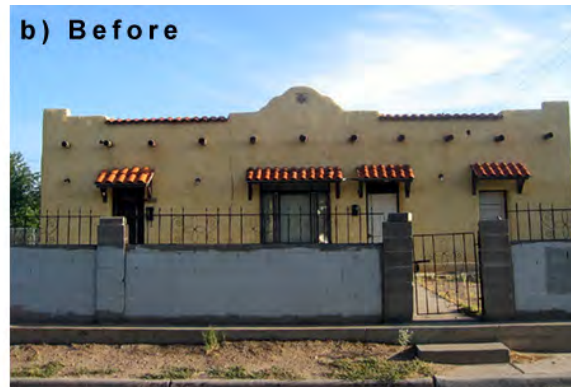
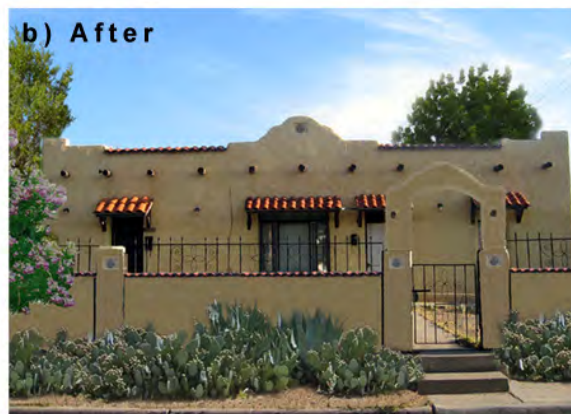
Facade enhancements shown above include new paint, tile accents, and an archway for the wall and new plantings

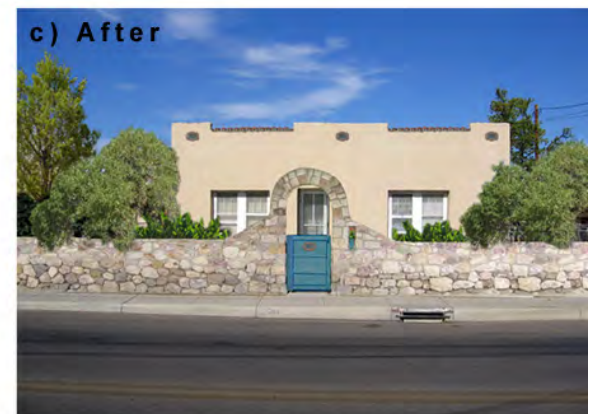
Facade enhancements shown above include new tile accents on the roof, a new wall, archway, gate, and plants

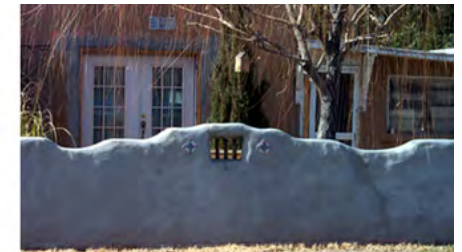
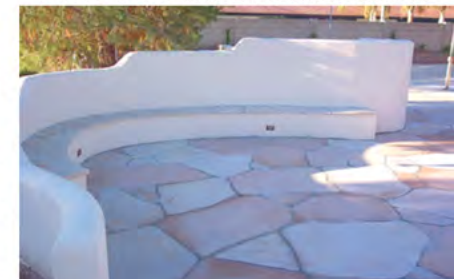
Adobe Walls with Decorative Accents

Suggested options for hardscape enhancement include pigmented or color washed/stained concrete paving in traditional colors, possibly with brick, stone, or tile inset detailing, at prominent streetscape locations (i.e. gateway areas, major intersections, in park or plaza areas, and along the edges of sidewalks and/or planting strips on major pedestrian routes). Additionally, low adobe & stucco walls, possibly with seating bays and brick, stone, or tile inset detailing could be placed in similar locations.

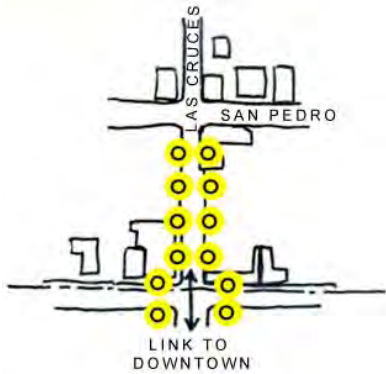
Intersections & Gateways

Historically appropriate style street lights can also add tremendous character and visual unity to the neighborhood while increasing pedestrian safety. The systematic replacement of the current “cobrahead” fixtures with historically sensitive street lights would make a major positive improvement to the traditional character of the area.

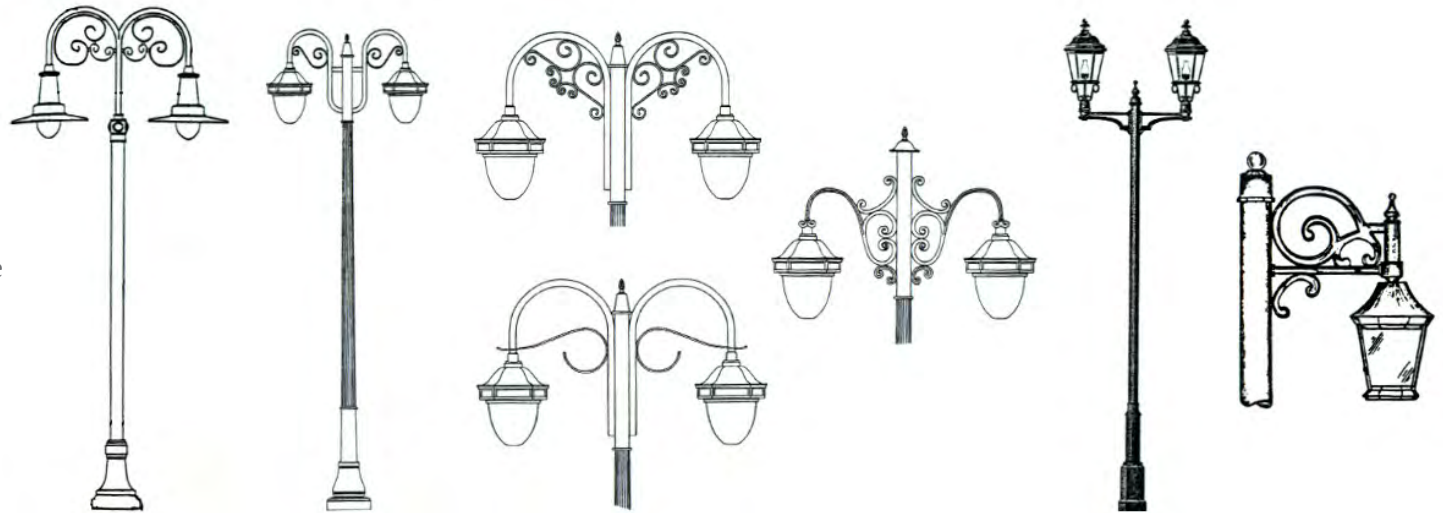
Possible Lighting Types & Details

A number of different lighting styles, such as those illustrated below, could be utilized to reflect and enhance the historic character of the Mesquite Neighborhood. Further research is recommended to determine the best suited, most historically accurate style of light fixture.

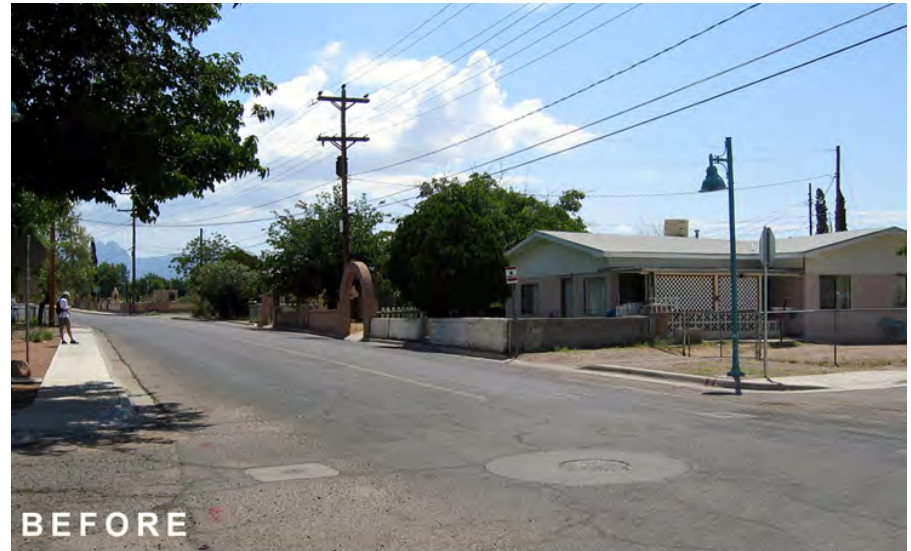
Improvements to existing sidewalks, the creation of new sidewalks where necessary, and the enhancement of pedestrian crossings with visible, specialty paving would all help to make the Mesquite Historic Neighborhood a safer, more welcoming pedestrian environment.

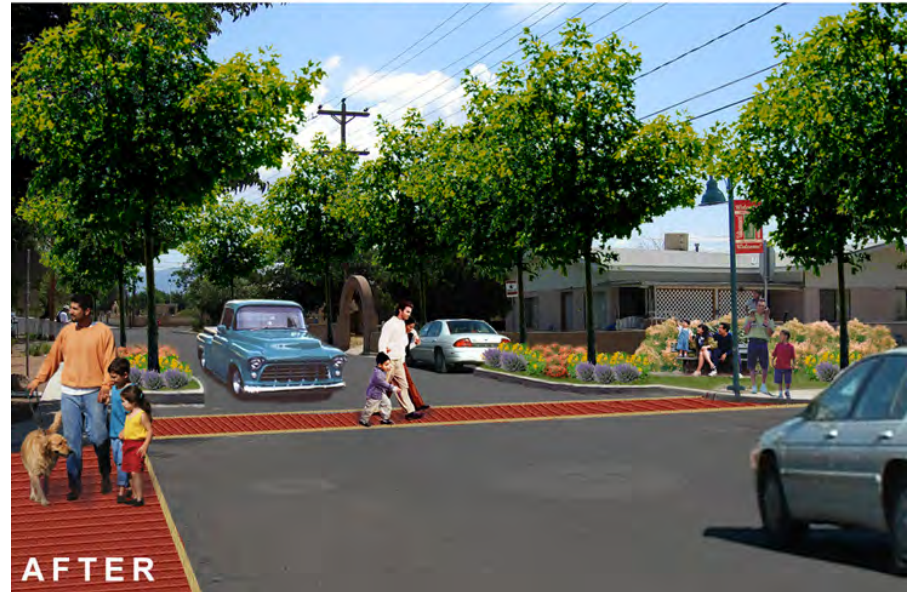
As illustrated below, the introduction of periodic bump-outs planted with shade trees and flowering plants, visible specialty paving at crosswalks, and additional streetlamps and furnishings all combine to create a pleasant, welcoming, and pedestrian-friendly streetscape.
